Hornsea Project Three Offshore Wind Farm

Environmental Statement:
Volume 6, Annex 2.4 – Hydrological Characterisation Report

PINS Document Reference: A6.6.2.4
APFP Regulation 5(2)(a)

Date: May 2018

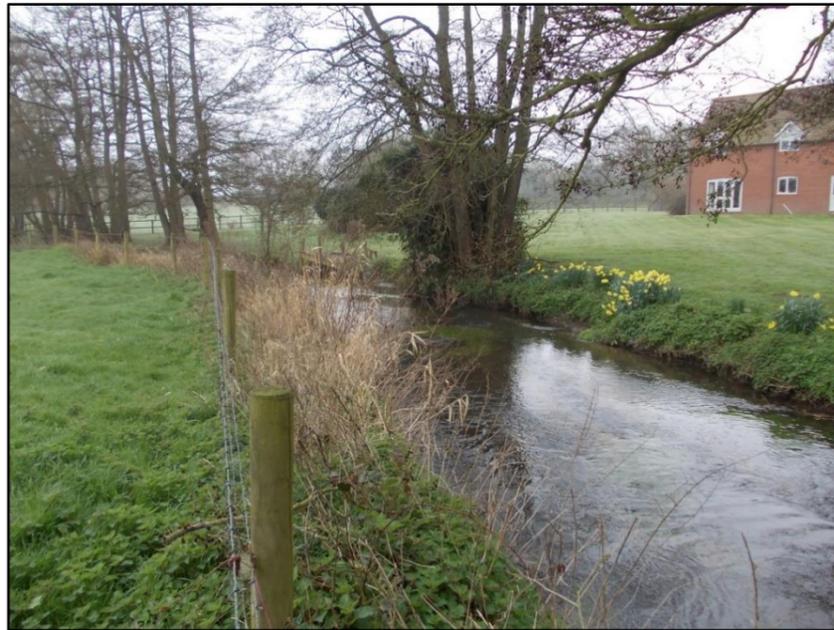
3.2.1.1 The River Bure flows west to east in an open channel across the onshore cable corridor (Figure 3.1). During the site visit the channel was observed to have a constant flow of water across the whole section. A pond feature is also present south of the River Bure within the study area.

Figure 3.1: River Bure.

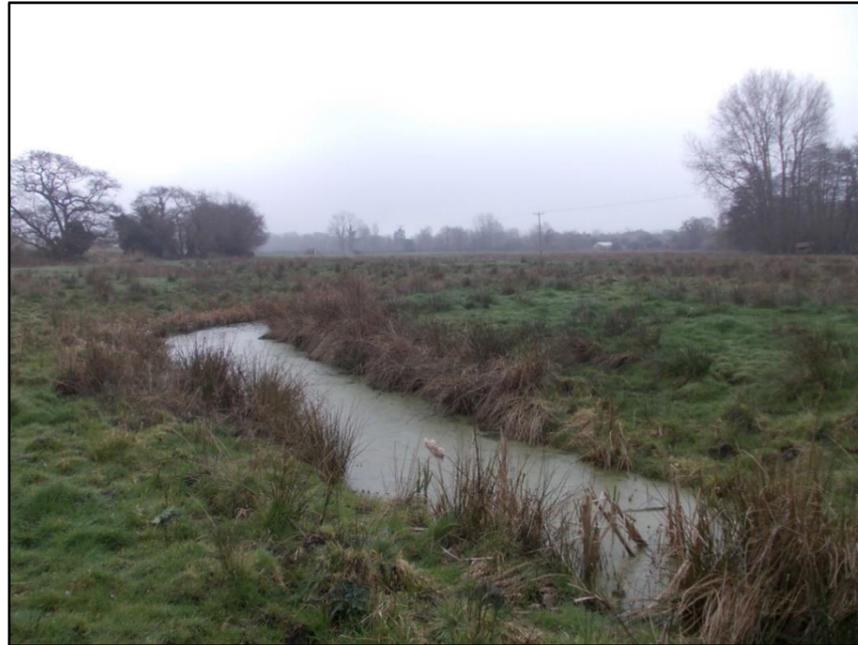
- 3.2.1.4 Field drains within the onshore cable corridor have a constant volume of water within the channel (Figure 3.3). During the site visit, the flow was slow/stagnant with algae growing on the surface.

Figure 3.3: Field drain within the study area 1.

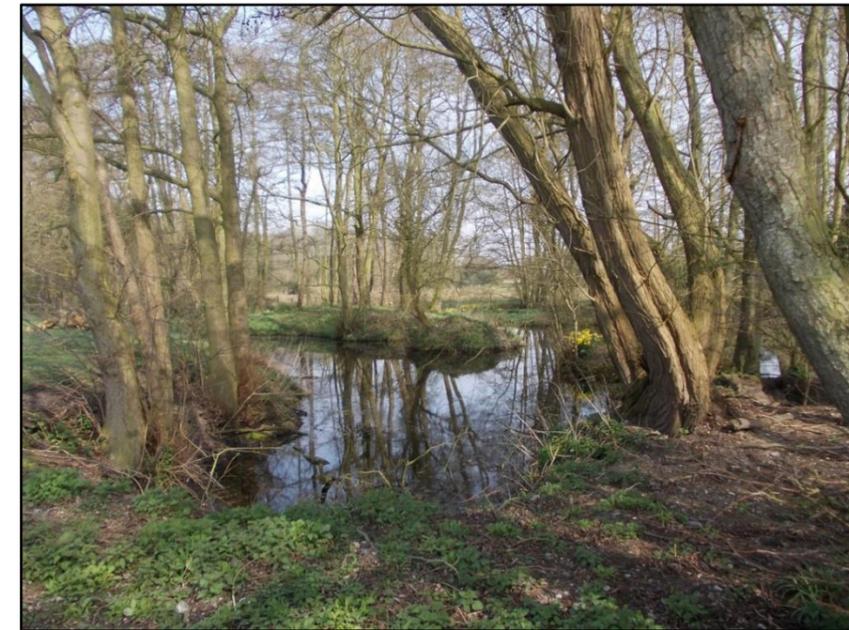
Figure 3.4: Pond feature south of the River Bure.

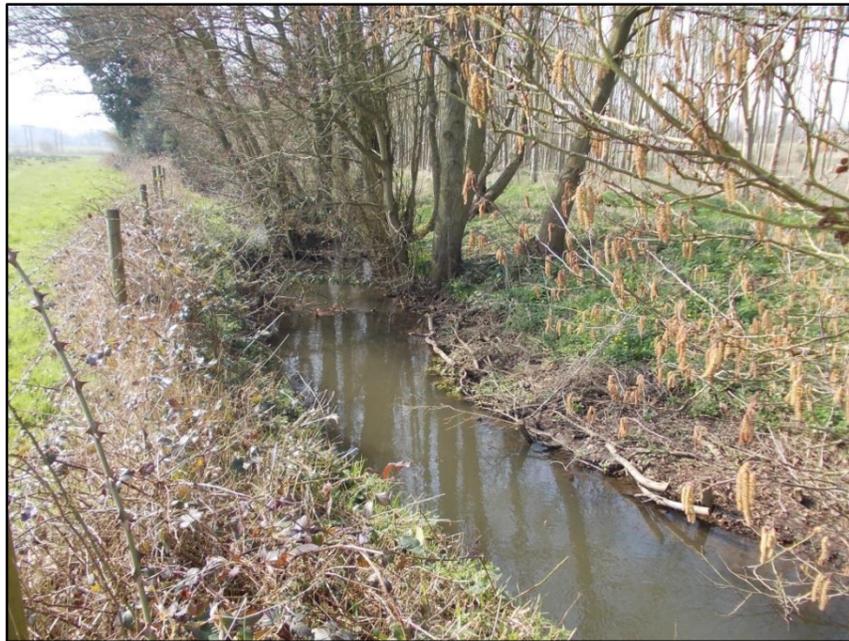
4.2.1.1 The Blackwater Drain flows in a westerly direction in an open channel across the onshore cable corridor (Figure 4.1). The drain flows along the boundary of Booton Common with a constant flow of water within the channel at the time of the site visit.

Figure 4.1: Blackwater Drain.

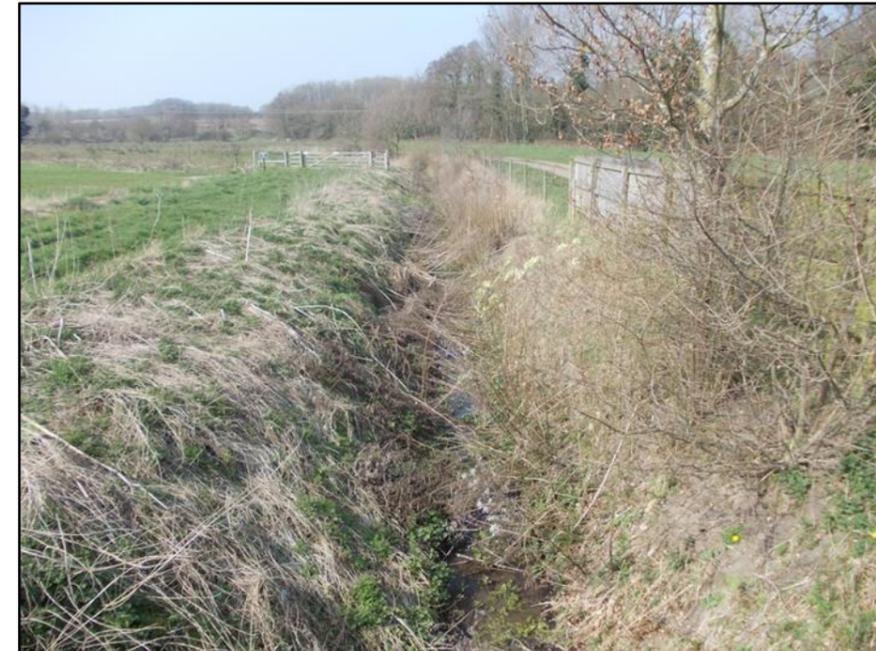
Figure 4.3: Feeder channel to Blackwater Drain.

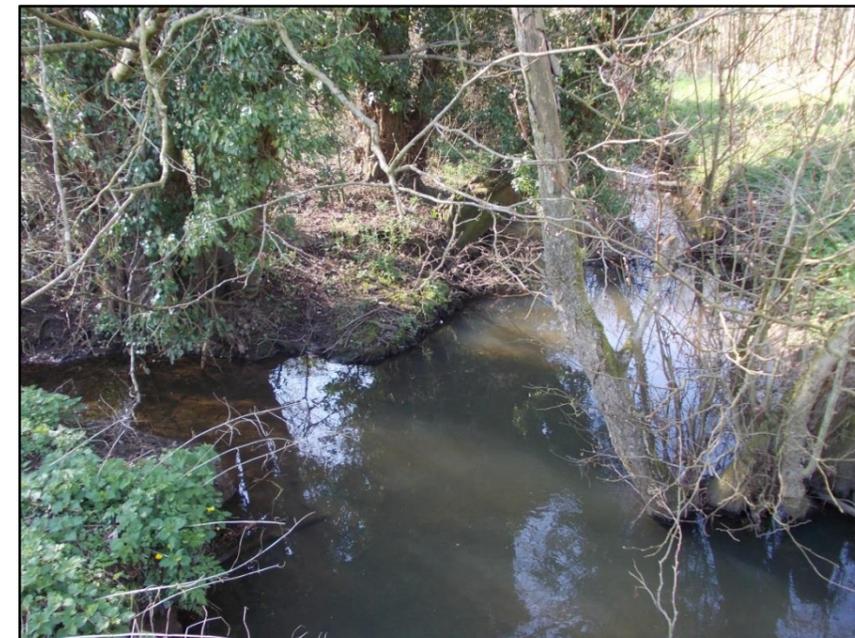
Figure 4.4: Feeder drain discharges to Blackwater Drain.

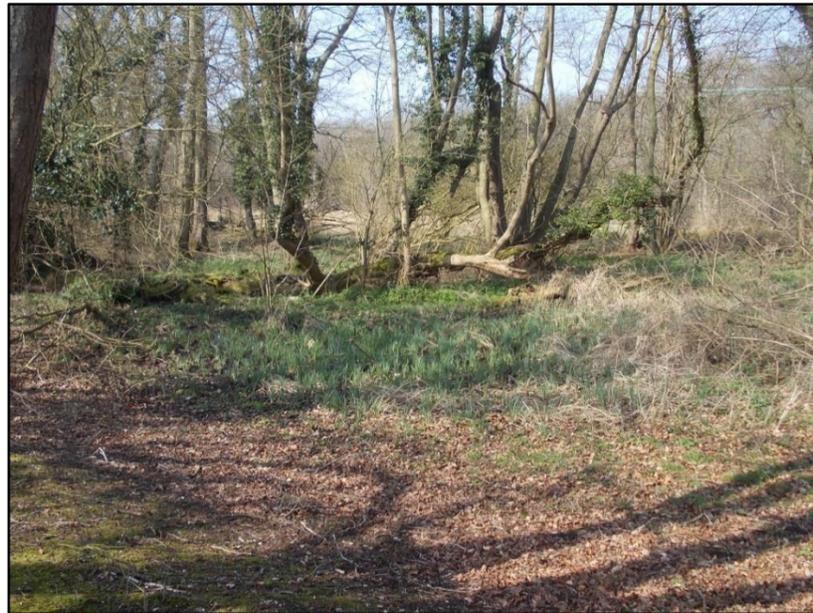
Figure 4.5: Booton Common SSSI and Norfolk Valley Fens SAC.

- 4.3.1.1 The Booton Common Site of Special Scientific Interest (SSSI) (Figure 4.5) totals approximately 8.1 ha, with approximately 3.20 ha located in the study area. The Booton Common SSSI runs parallel to Blackwater Drain in the east of the study area. Booton Common SSSI is one of the component sites making up Norfolk Valley Fens SAC.

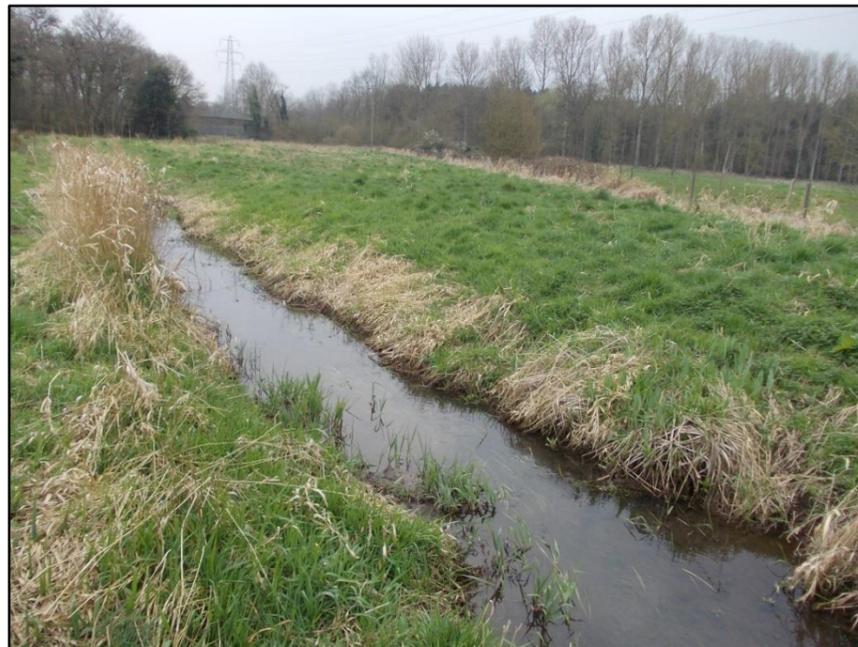
5.2.1.1 The Beck flows in an open channel across the onshore cable corridor (Figure 5.1). At the time of the site visit the Beck had a reasonable volume of water within the channel. The site is generally flat around the drain sloping gently towards a narrow but densely wooded strip crossing the onshore cable corridor towards the northern end of the crossing.

Figure 5.1: Swannington Beck.

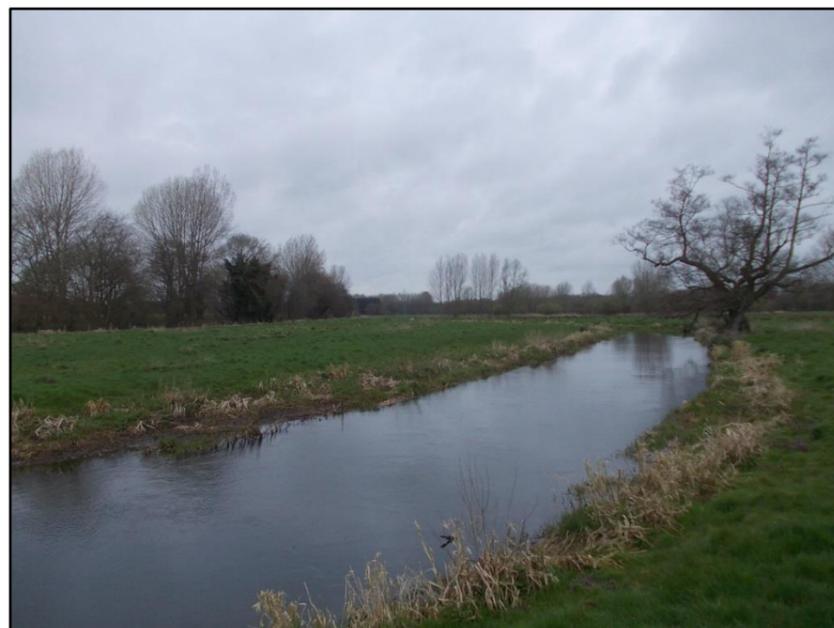
Figure 6.1: River Wensum.

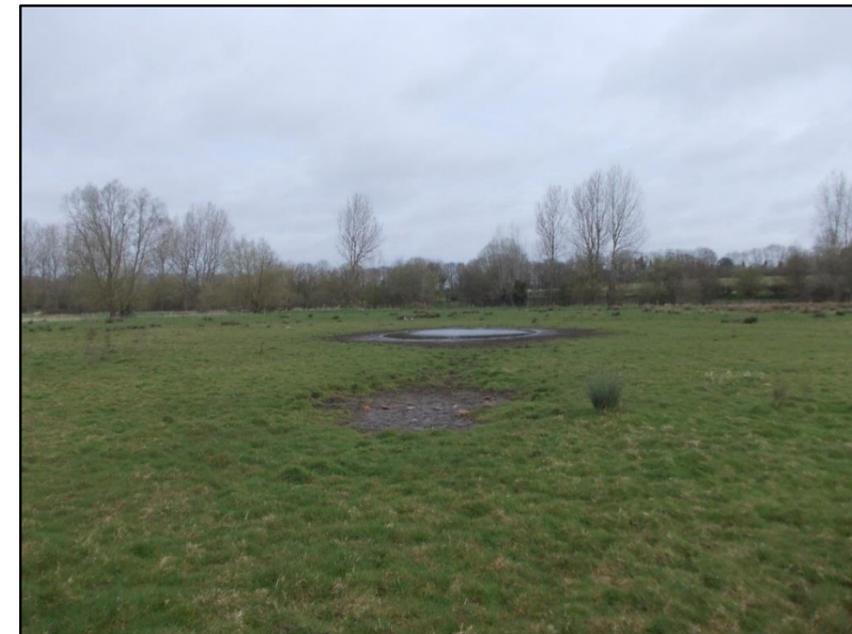
6.2.1.3 No additional streams were identified during the site visit. A pond area is present immediately to the west of the onshore cable corridor (Figure 6.2). The area around the pond is boggy. Limited potential for infiltration within this area.

Figure 6.2: Pond to the west of the onshore cable.

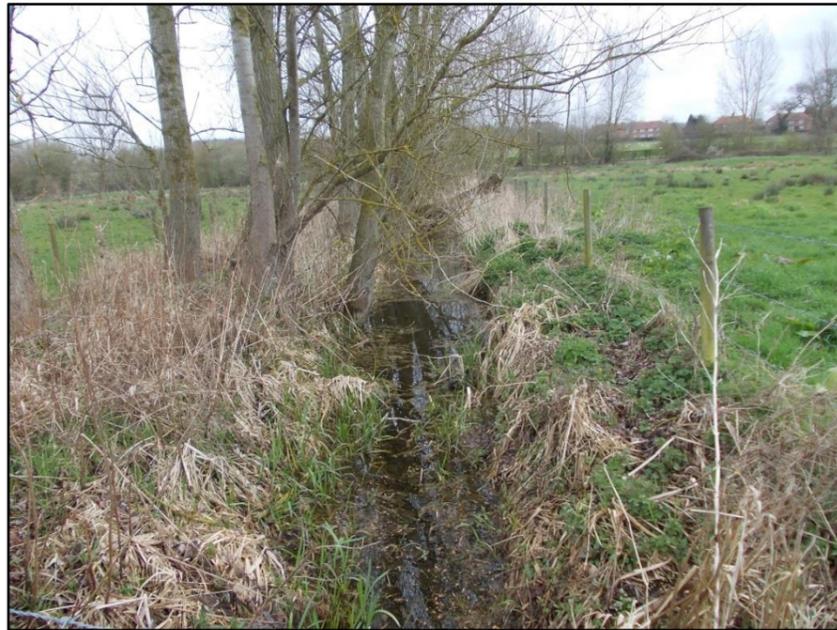
6.2.1.4 The IDB drain to the north of the River Wensum is an open cut channel and was slow moving at the time of the site visit (Figure 6.4). The IDB drain is a tributary of the River Wensum.

Figure 6.4: IDB drain tributary of the River Wensum.

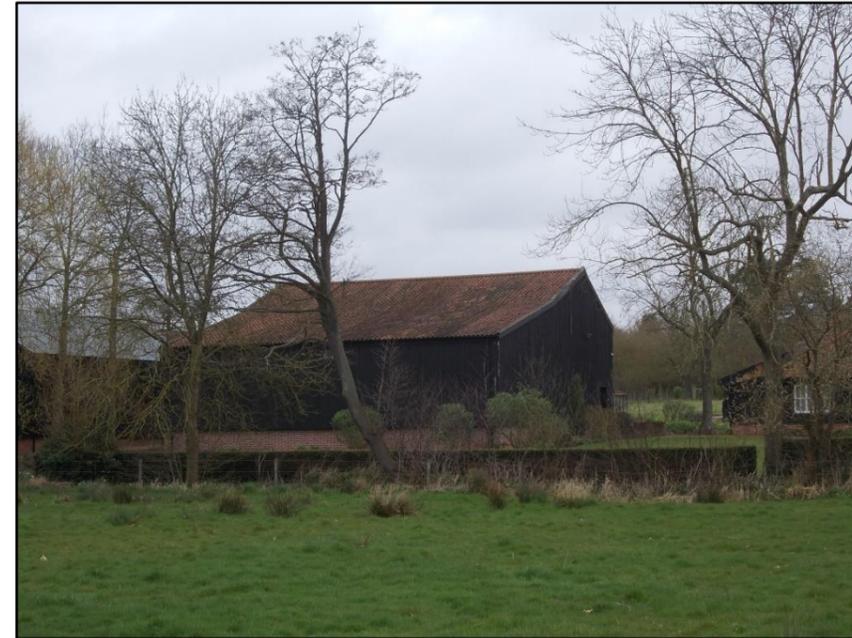
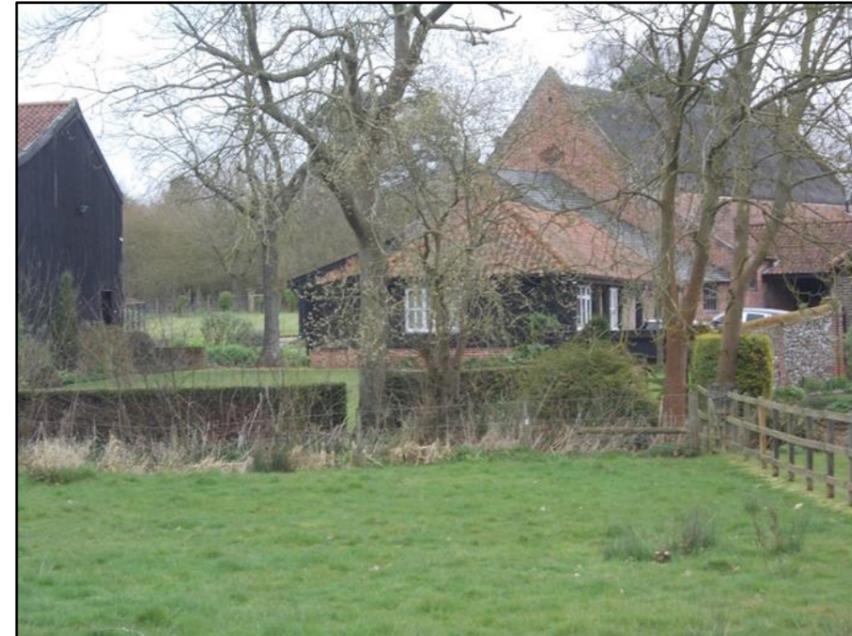
6.2.1.11 The property immediately north east of the IDB drain may have flood mitigation built into the building design. A brick base has been built into the barns allowing around 1 m extra protection from flooding (Figure 6.6).

Figure 6.6: Flood defences built into barns.

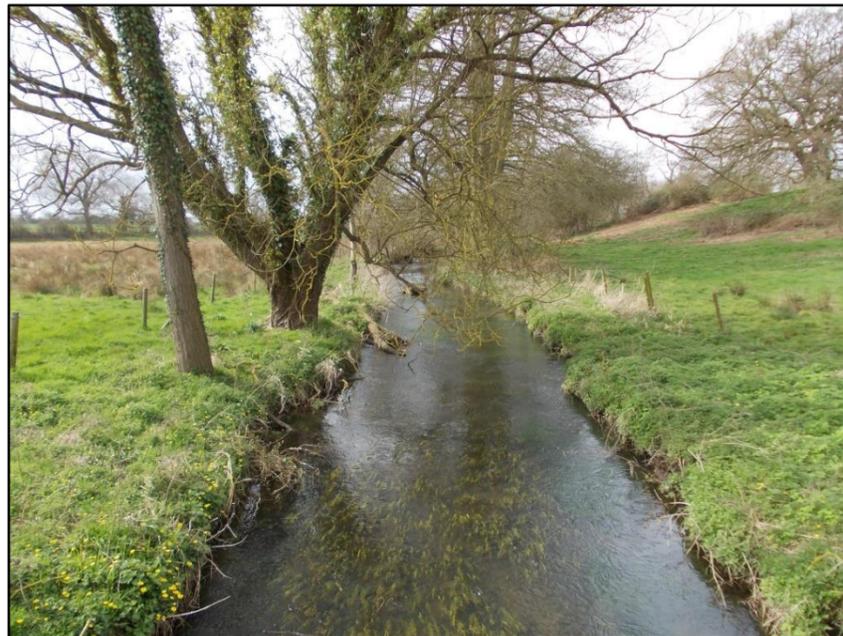
Figure 7.1: River Tud.

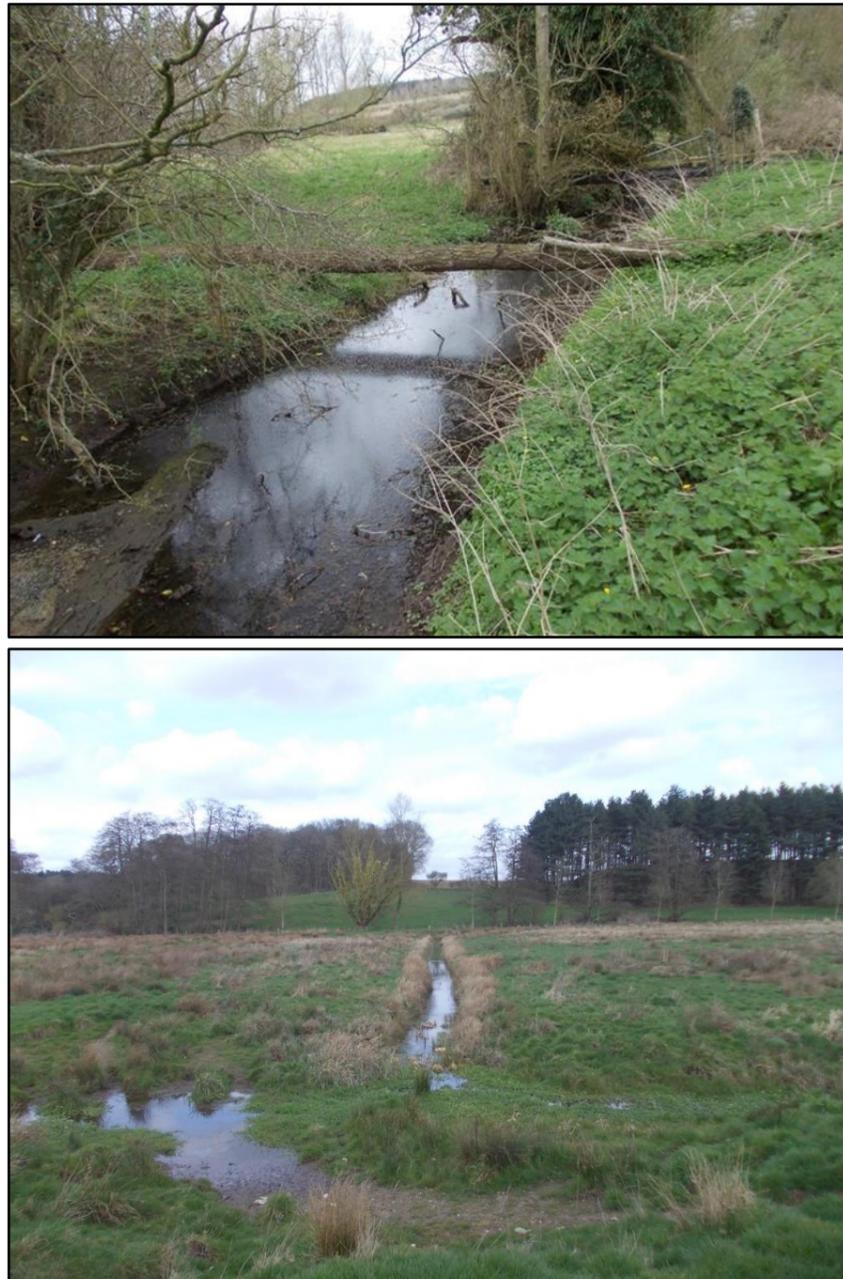
7.2.1.3 To the south of the River Tud, there is a network of field drains which intercept surface water from the agricultural land (see Figure 7.3). The field drains were slow flowing/still at the time of the site visit.

Figure 7.3: Field drains in the study area 5.

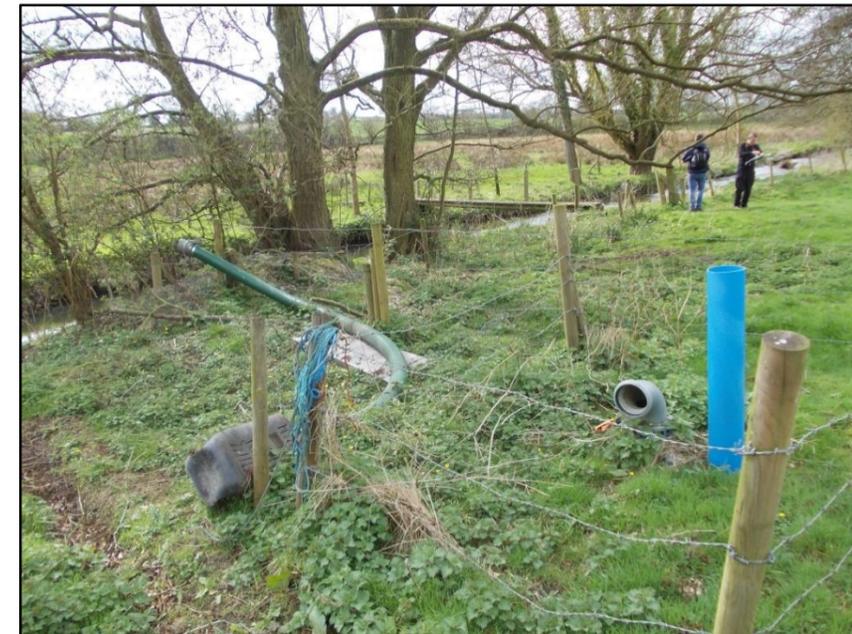
7.2.1.4 In the study area, there are two licensed abstractions from the River Tud, which are operated by Honingham Aktieselskab (Easton Estates). Both are located in between the onshore cable corridor and Ringland Road (E 613110, N 311470) (see Figure 7.4). One is used for direct spray irrigation and one is used extracting water to storage prior to spray irrigation.

Figure 7.4: Licensed abstractions from the River Tud.

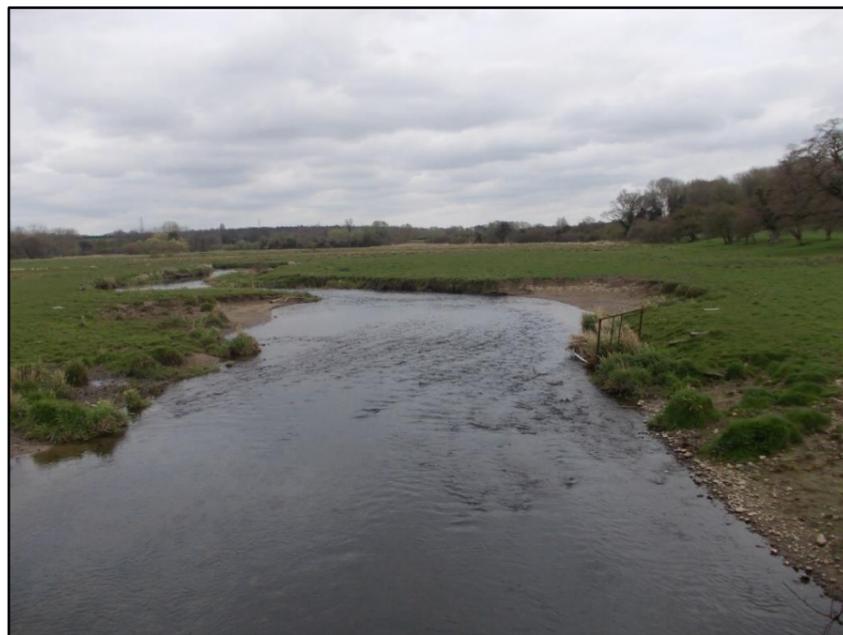
Figure 8.1: River Yare.

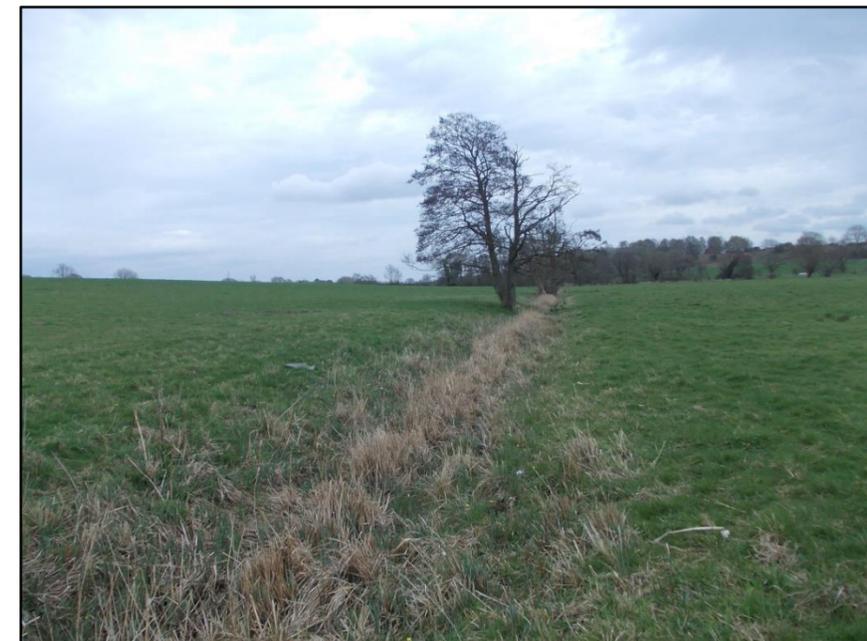
8.2.1.5 A number of field drains are present within the onshore cable corridor including a stream which runs parallel to river to the north. At the time of the site visit, the field drains were relatively slow flowing with vegetation across the banks (see Figure 8.2).

Figure 8.2: Field drain in study area 6.

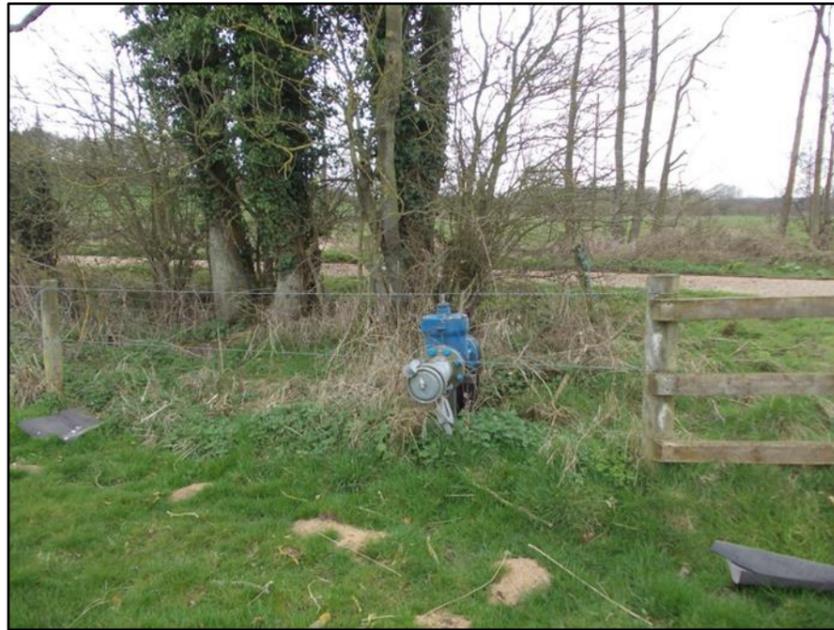
- 8.2.1.6 There is one licensed surface water abstraction from the River Yare (Figure 8.4). It is located at the centre of the study area, west of the bridge across the River Yare, within the onshore cable corridor (E 614030, N 308920). This abstraction point is owned by Great Melton Farms Ltd and is used for direct spray irrigation.

Figure 8.4: Licensed surface water abstraction at the River Yare.

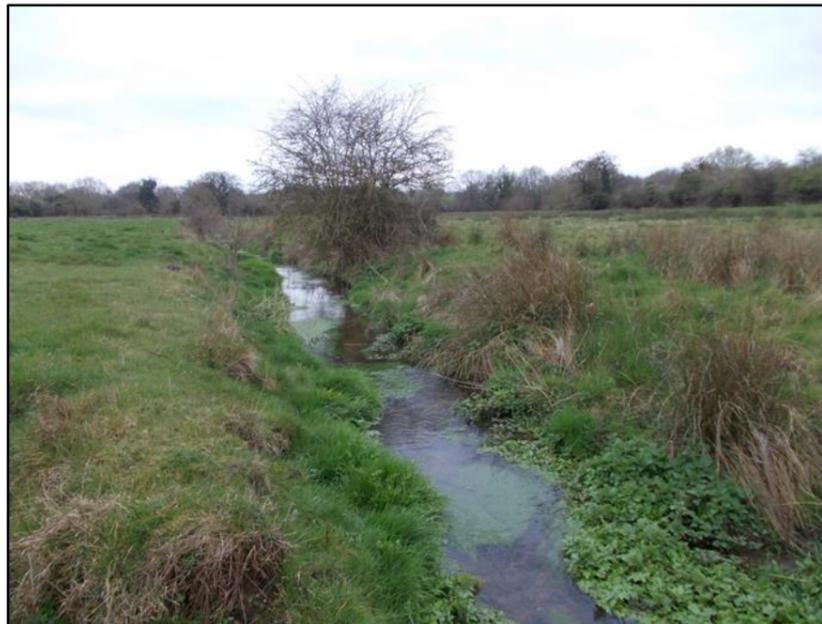
Figure 9.1: Intwood Stream.

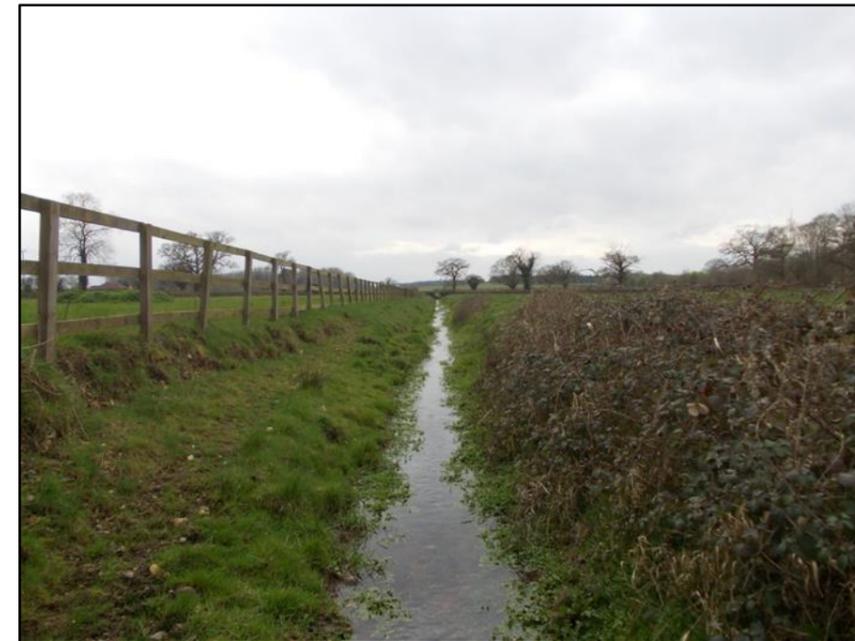
9.2.1.3 There is a stream which flows from the west of the study area, inside the onshore cable corridor, through Spruce's Plantation, until it joins Intwood Stream in the north of the study area (pictured in Figure 9.2). The stream is open cut with a constant flow of water within the channel. The topography from the banks is flat lying grassland.

Figure 9.2: Tributary of Intwood Stream.

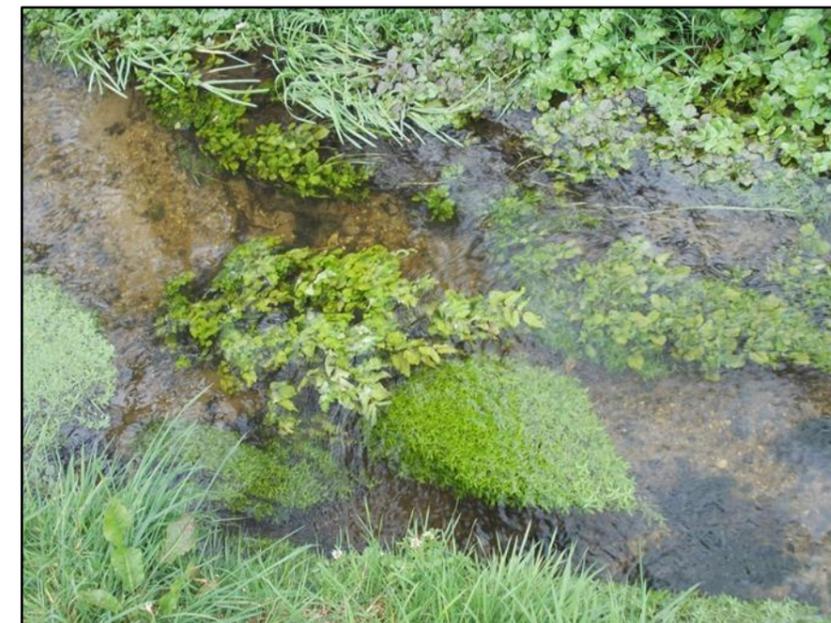
9.3.1.7 The section of the Intwood Stream has a good range of in-channel vegetation and a clean gravelly channel bottom with sandy patches (see Figure 9.4 below).

Figure 9.4: Aquatic features of Intwood Stream.

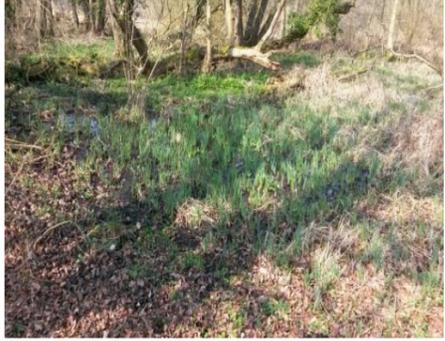
Target Note	Description	Site Photos
1.	Booton Common SSSI/SAC – valley fen and birch/willow wet woodland. Evidence of flushes feeding wetland habitats as well as surface waters from upslope. These appear to be physically separated from the upstream refined cable route corridor by a break in slope (at target note 3) and by the boundary ditches at the edge of the common. Further investigation of ground and surface water flows and interaction is probably required here.

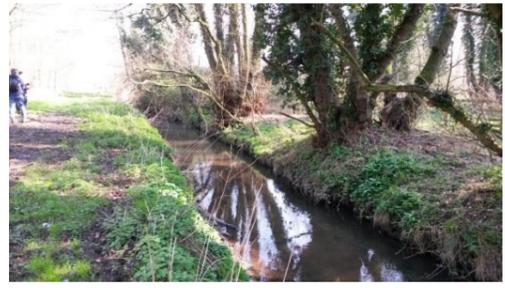
4.	The Blackwater Drain is tree-lined and shaded in parts. Where is more open there is some submerged aquatic plant growth and the channel bed is noted as being a mix of silty mud and more sandy, with areas of gravels also. There are a number of springs and flushes noted on both sides of the shallow valley.

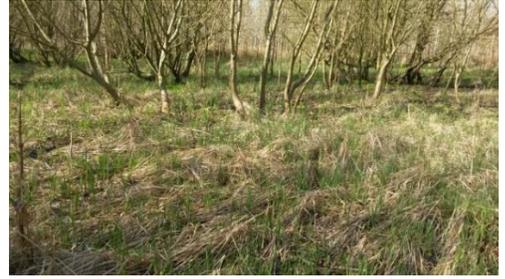
5.	Perched sedge bed in a valley side flush within the young woodland. Very wet conditions but drier quickly away from the flush both upslope and downslope.

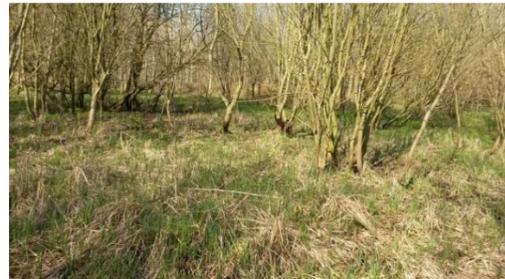
6.	Another very wet sedge bed and the bottom of the wooded valley slope.

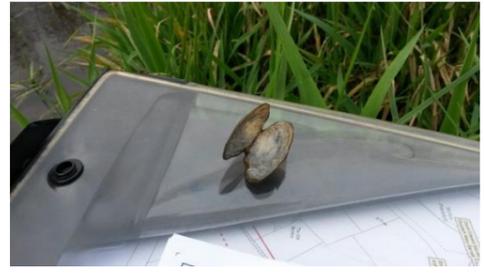
4.	At gravel side bar near willow island the river bed is cleaned by particularly fast riffle flows and swan mussels and other benthic invertebrates were observed in the shallows (not actively sampled).

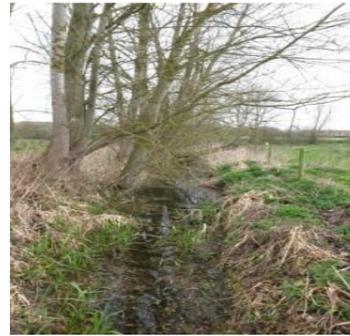
6.	Alder and willow tree line next to a sedge dominated water-filled ditch.

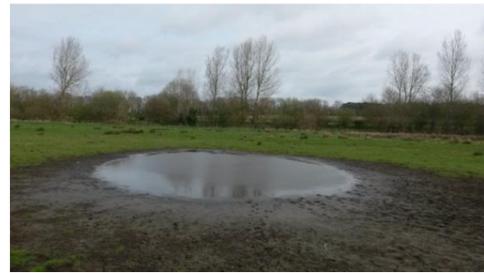
7.	Eastern feeder channel also with slow flow and abundant marginal and emergent vegetation.	
8.	Very shallow muddy pond where surface water has collected. No evident aquatic vegetation.

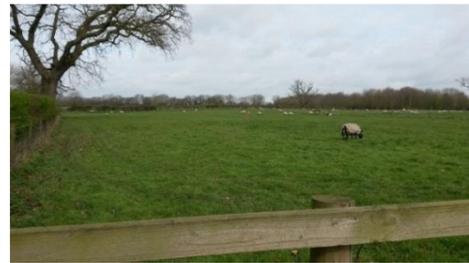
9.	Snipe flushed from marginal vegetation of river.	
10.	Improved grassland on the raised fields above the flood plain.

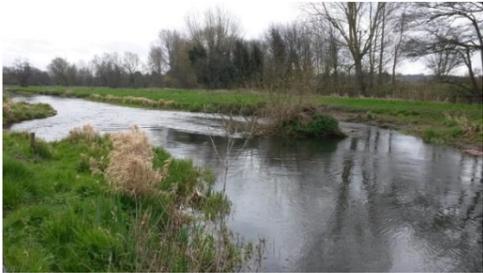
4.	The River Wensum is a high quality, diverse gravel bed watercourse with a good range of riverine features including an in-channel willow island. A good range of submerged, emergent and marginal vegetation including reed sweet grass, pond sedge, rushes and others.

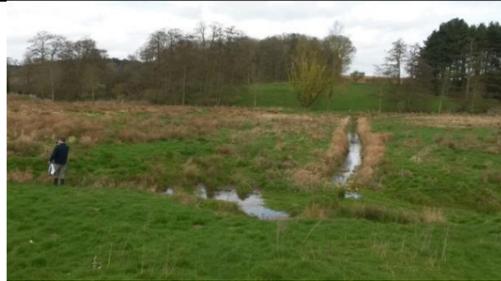
Target Note	Description	Site Photos
1.	River Tud valley floor marshy grassland south of the river is CWS. Sward is tussocky and wet with abundant rush and some sedge and reed sweet grass stands. Good diversity of sward species with meadowsweet, buttercup spp. And others likely later in season. Frog spawn noted – 20+ clumps.

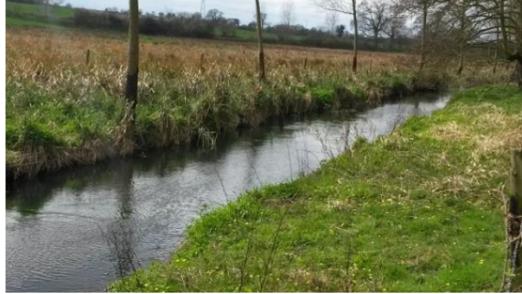
2.	River Tud is a high quality, diverse gravel bed watercourse with a good range of submerged, emergent and marginal vegetation including water-crowfoot, bur-reed and others within the channel.

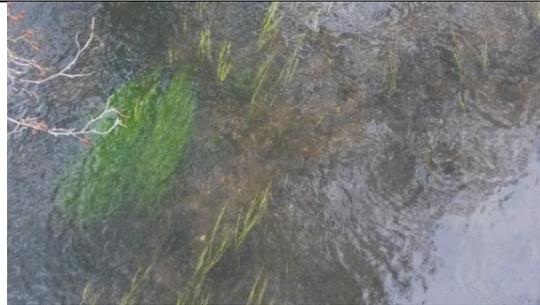
2.	Note the good range of submerged, emergent and marginal vegetation including water-crowfoot, bur-reed and others within the channel.

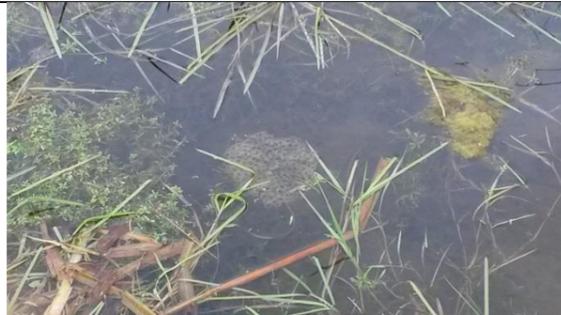
3.	7-10 clumps of frog spawn noted in one of the valley bottom ditches.

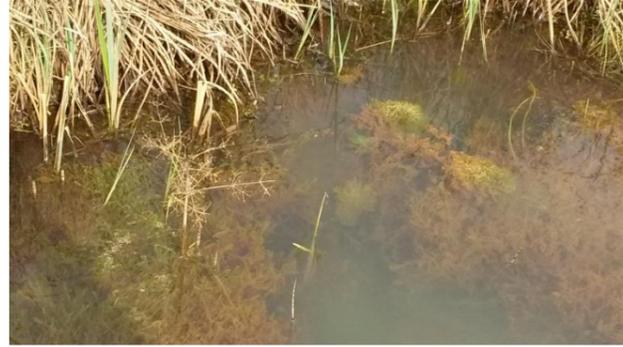
Target Note	Description	Site Photos
4.	In one of the valley bottom ditches possible water violet recorded, as well as water plantain and aquatics – ditch system is good quality too.

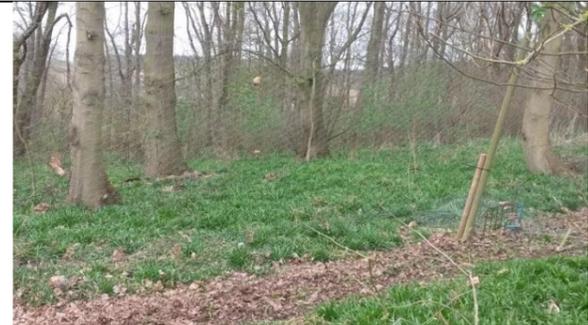
5.	On north bank the topography rises quickly. The grassland is much drier and appears to be species-poor semi-improved but should be re-checked later in season if the field is to be directly affected. In valley bottom by the river there are remnant sedgebeds where there ground is wettest.	
6.	CWS is an oak, beech and ash bluebell wood, although game management is strongly evident the quality of the woodland is still apparent.

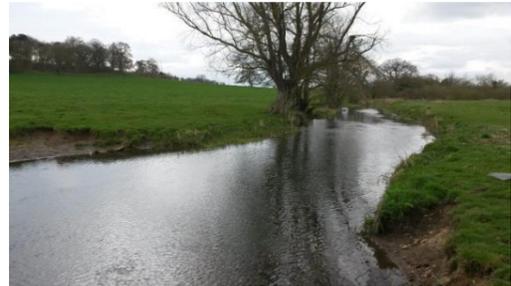
Target Note	Description	Site Photos
1.	River Yare is a larger river with a good clear fast flow with a sandy/gravel bed and a good range of riverine features as it meanders across the valley floor flood plain.

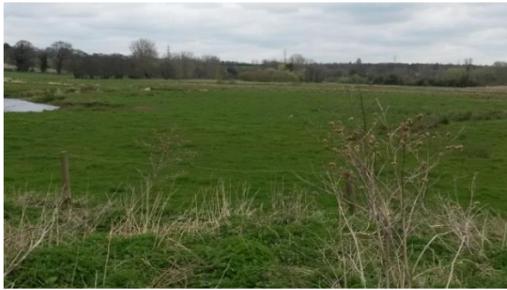
Target Note	Description	Site Photos
2.	Valley bottom grassland has characteristics of marshy grassland and is wet in places with rushy patches, although not a diverse sward suggesting it has been improved in the past.

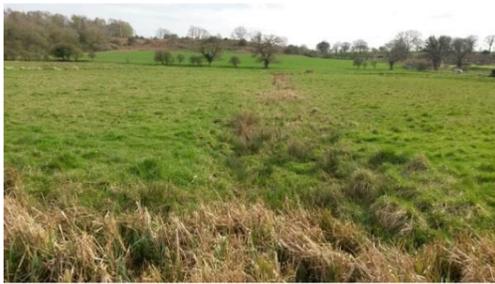
3.	Very shallow muddy pond of standing water with little or no aquatic vegetation, depth <10cm.	
4.	Locations of possible water vole burrows.	
5.	Within adjacent CWS a series of ponds and apparently wetter more diverse marshy grassland and reed habitat mosaic.	
6.	Snipe flushed.	
7.	Feeder ditches fully vegetated with reed sweet grass, pond sedge, rushes and other emergent species – grassland wetter east of the farm access road. Very little open water remaining.

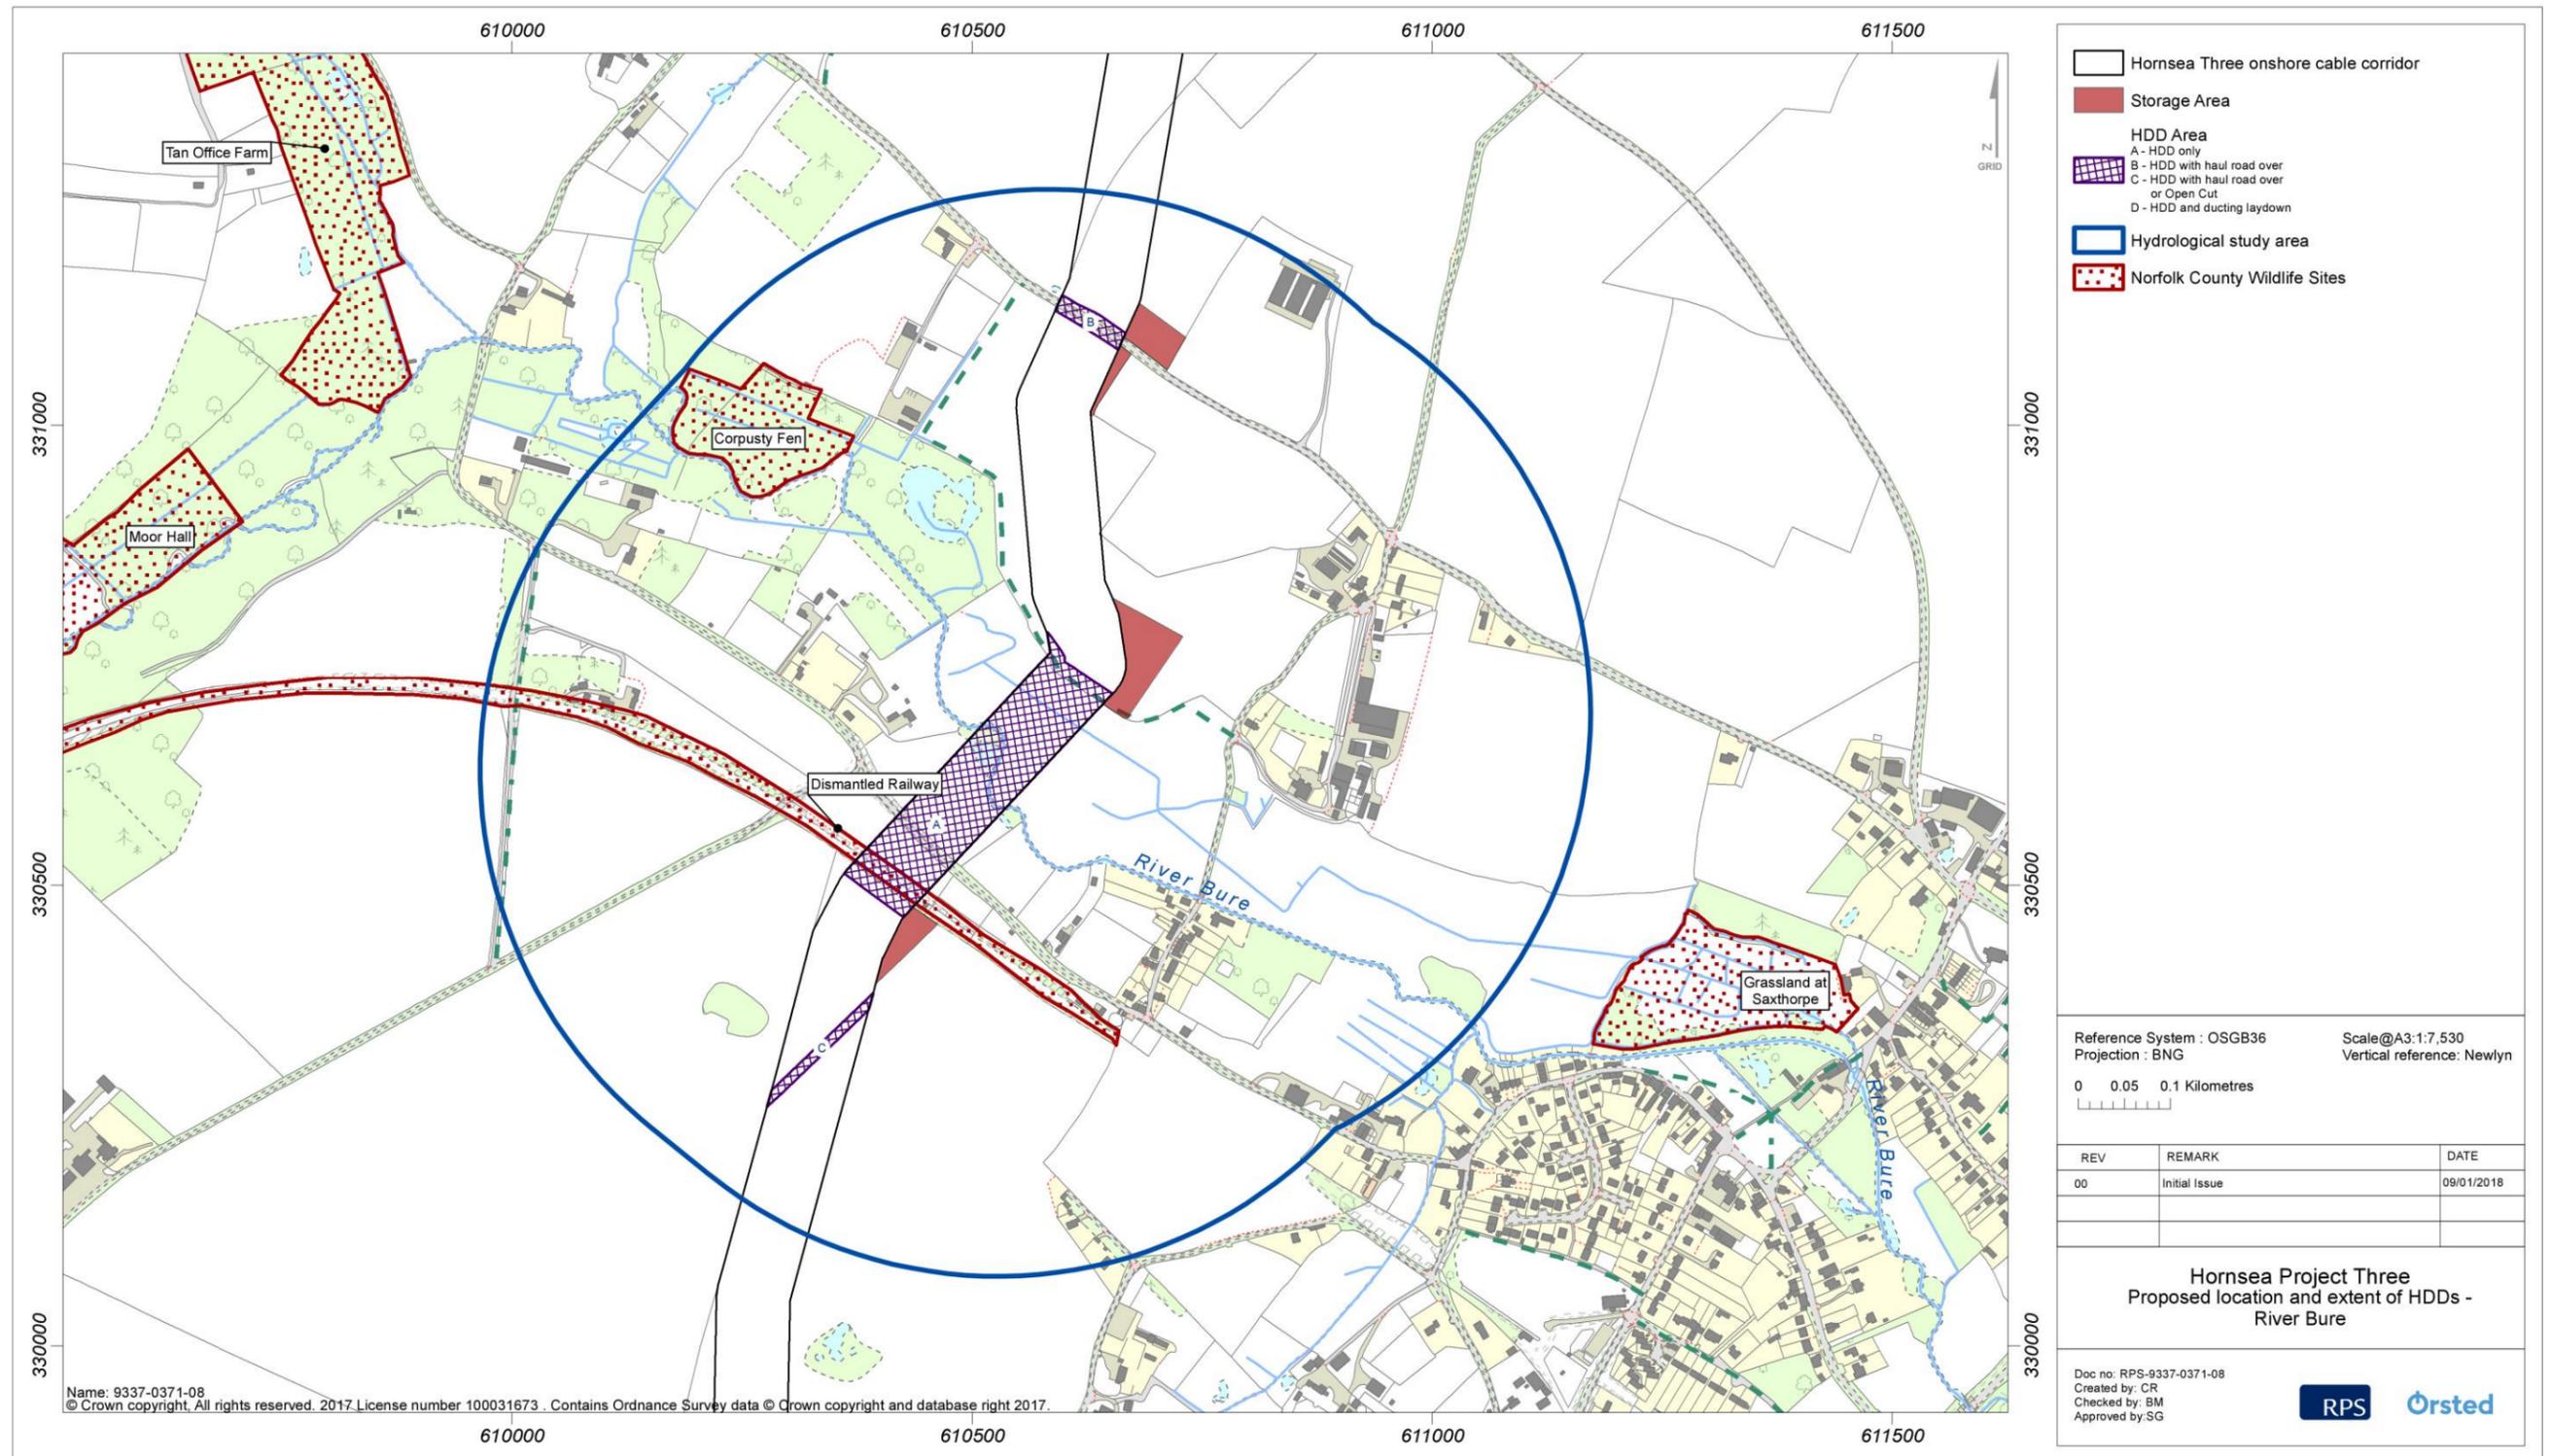
Figure C.10.8: Proposed location and extent of HDDs – River Bure.

3.6.1.6 The above noted natural gas pipeline crosses the onshore cable corridor approximately 150 m south of the proposed drill reception pit for the River Bure crossing. The gas pipeline will also be crossed by HDD (see the southern HDD area in Figure C.).
